The Enhanced Crash Investigation Study (ECIS)

Monash University Accident Research Centre, Australia

**A head-on crash on a 2-lane
undivided narrow rural hwy**

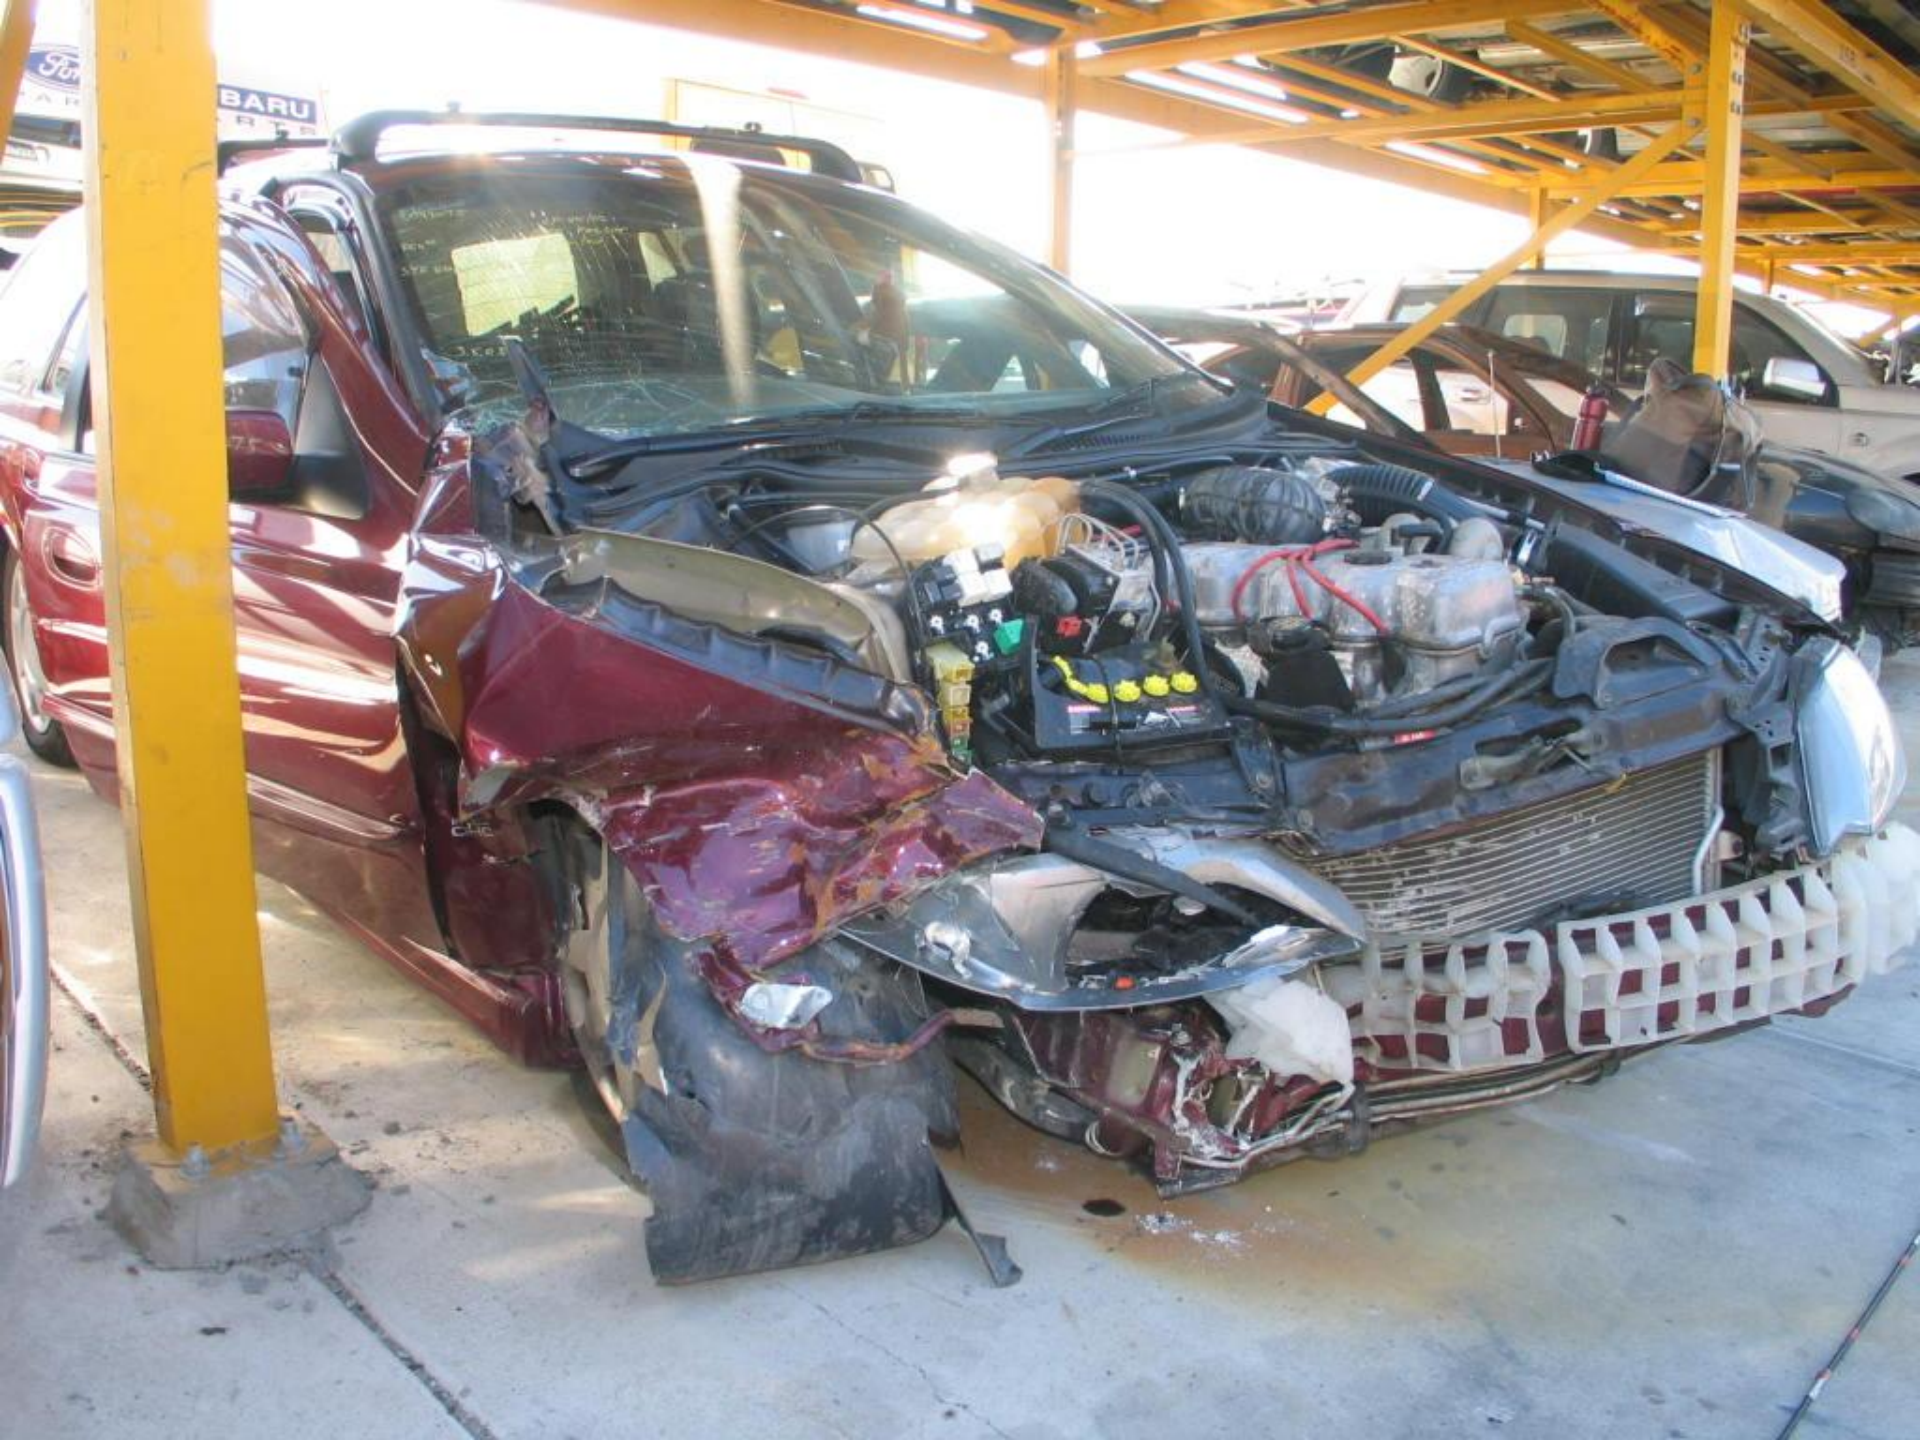
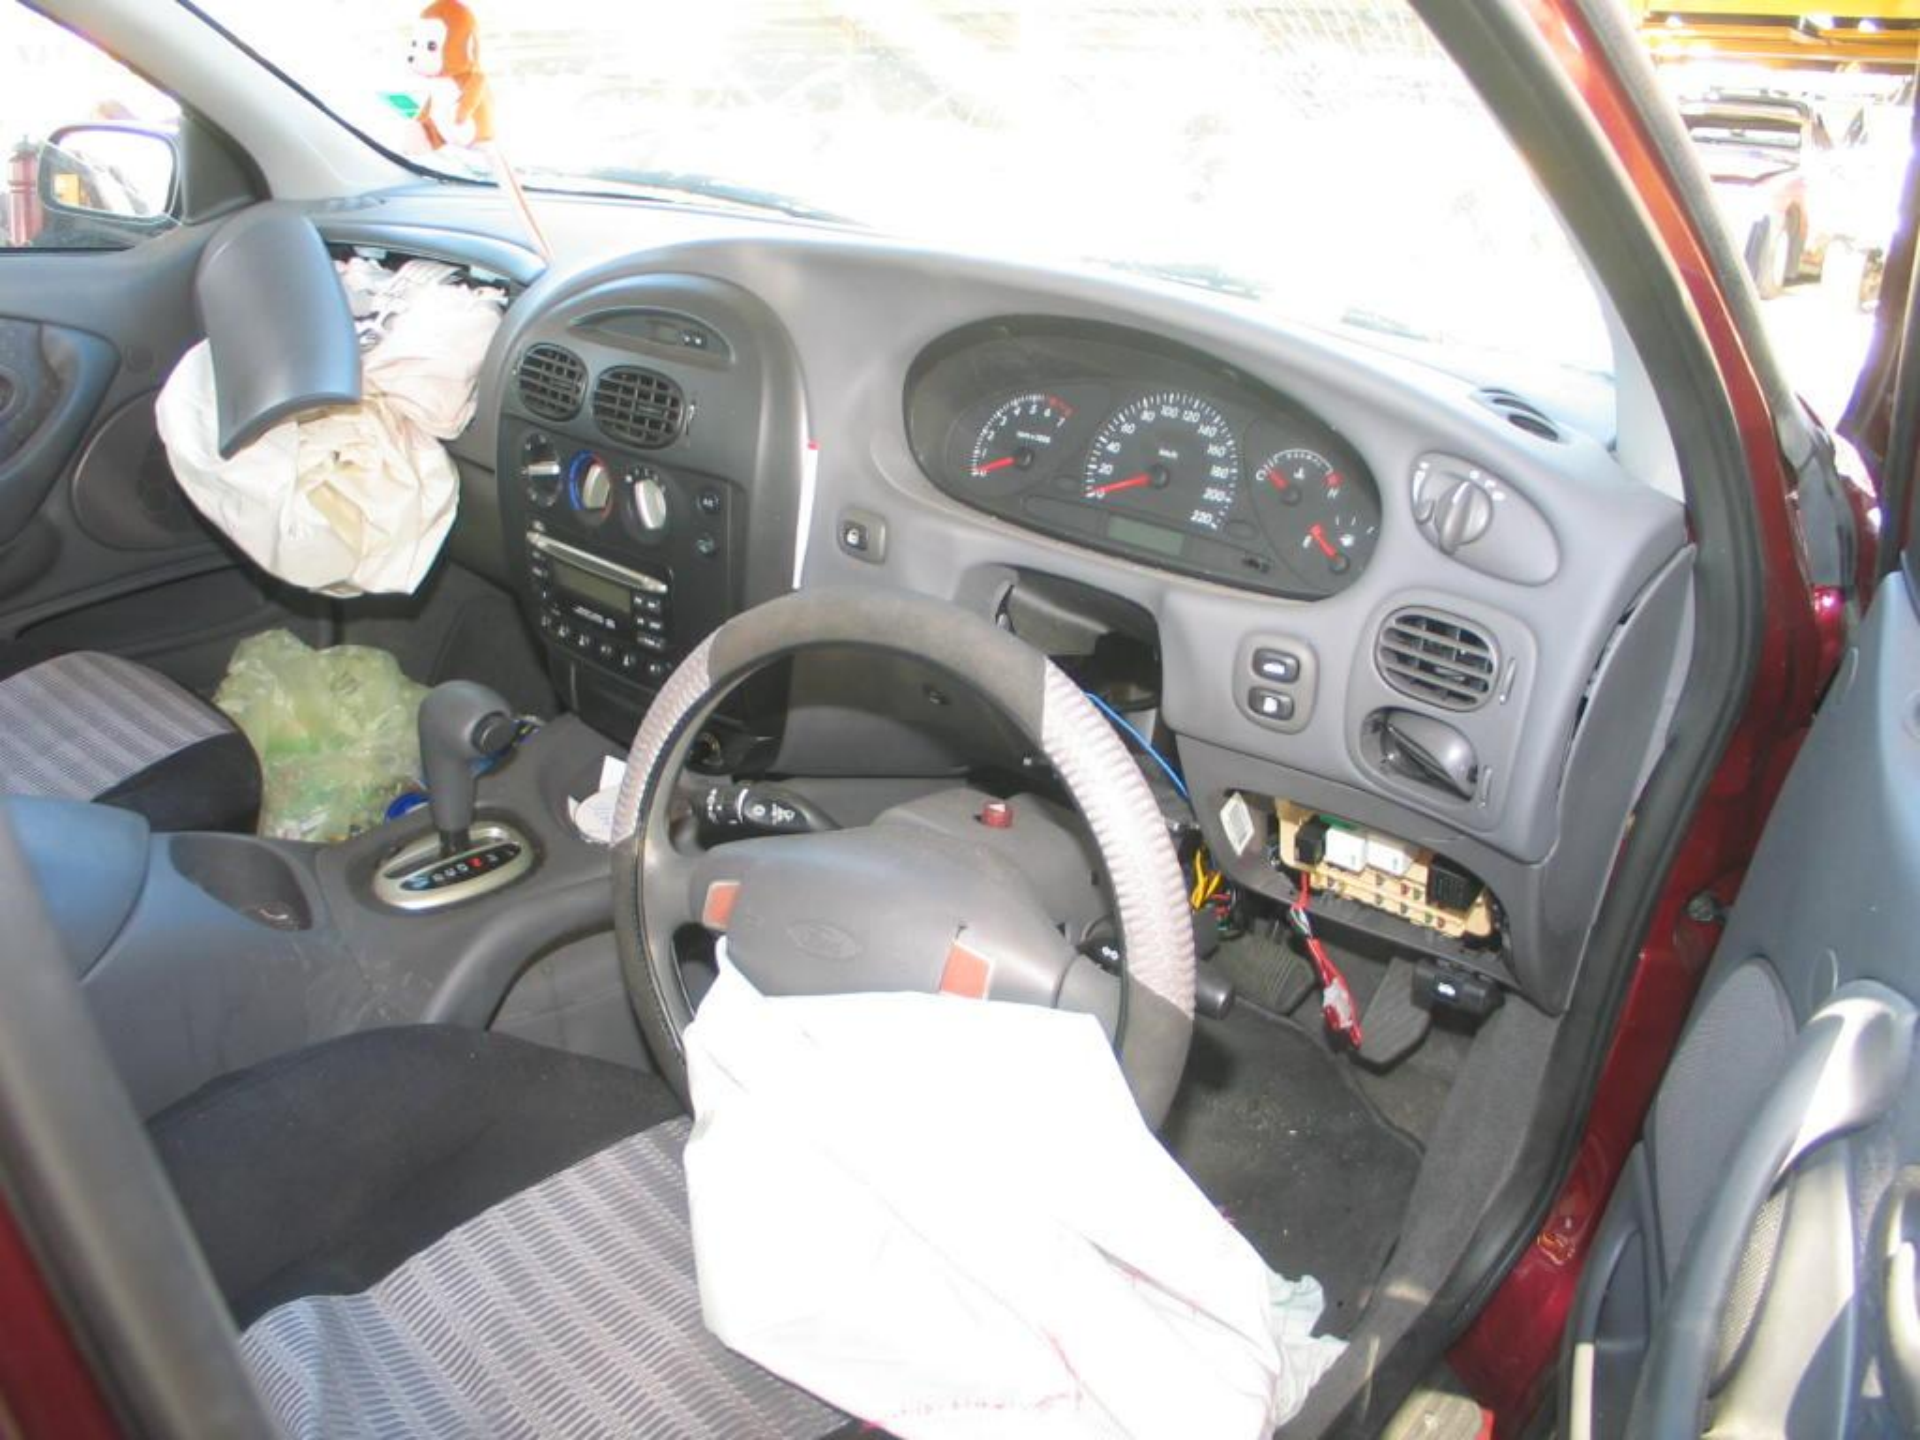
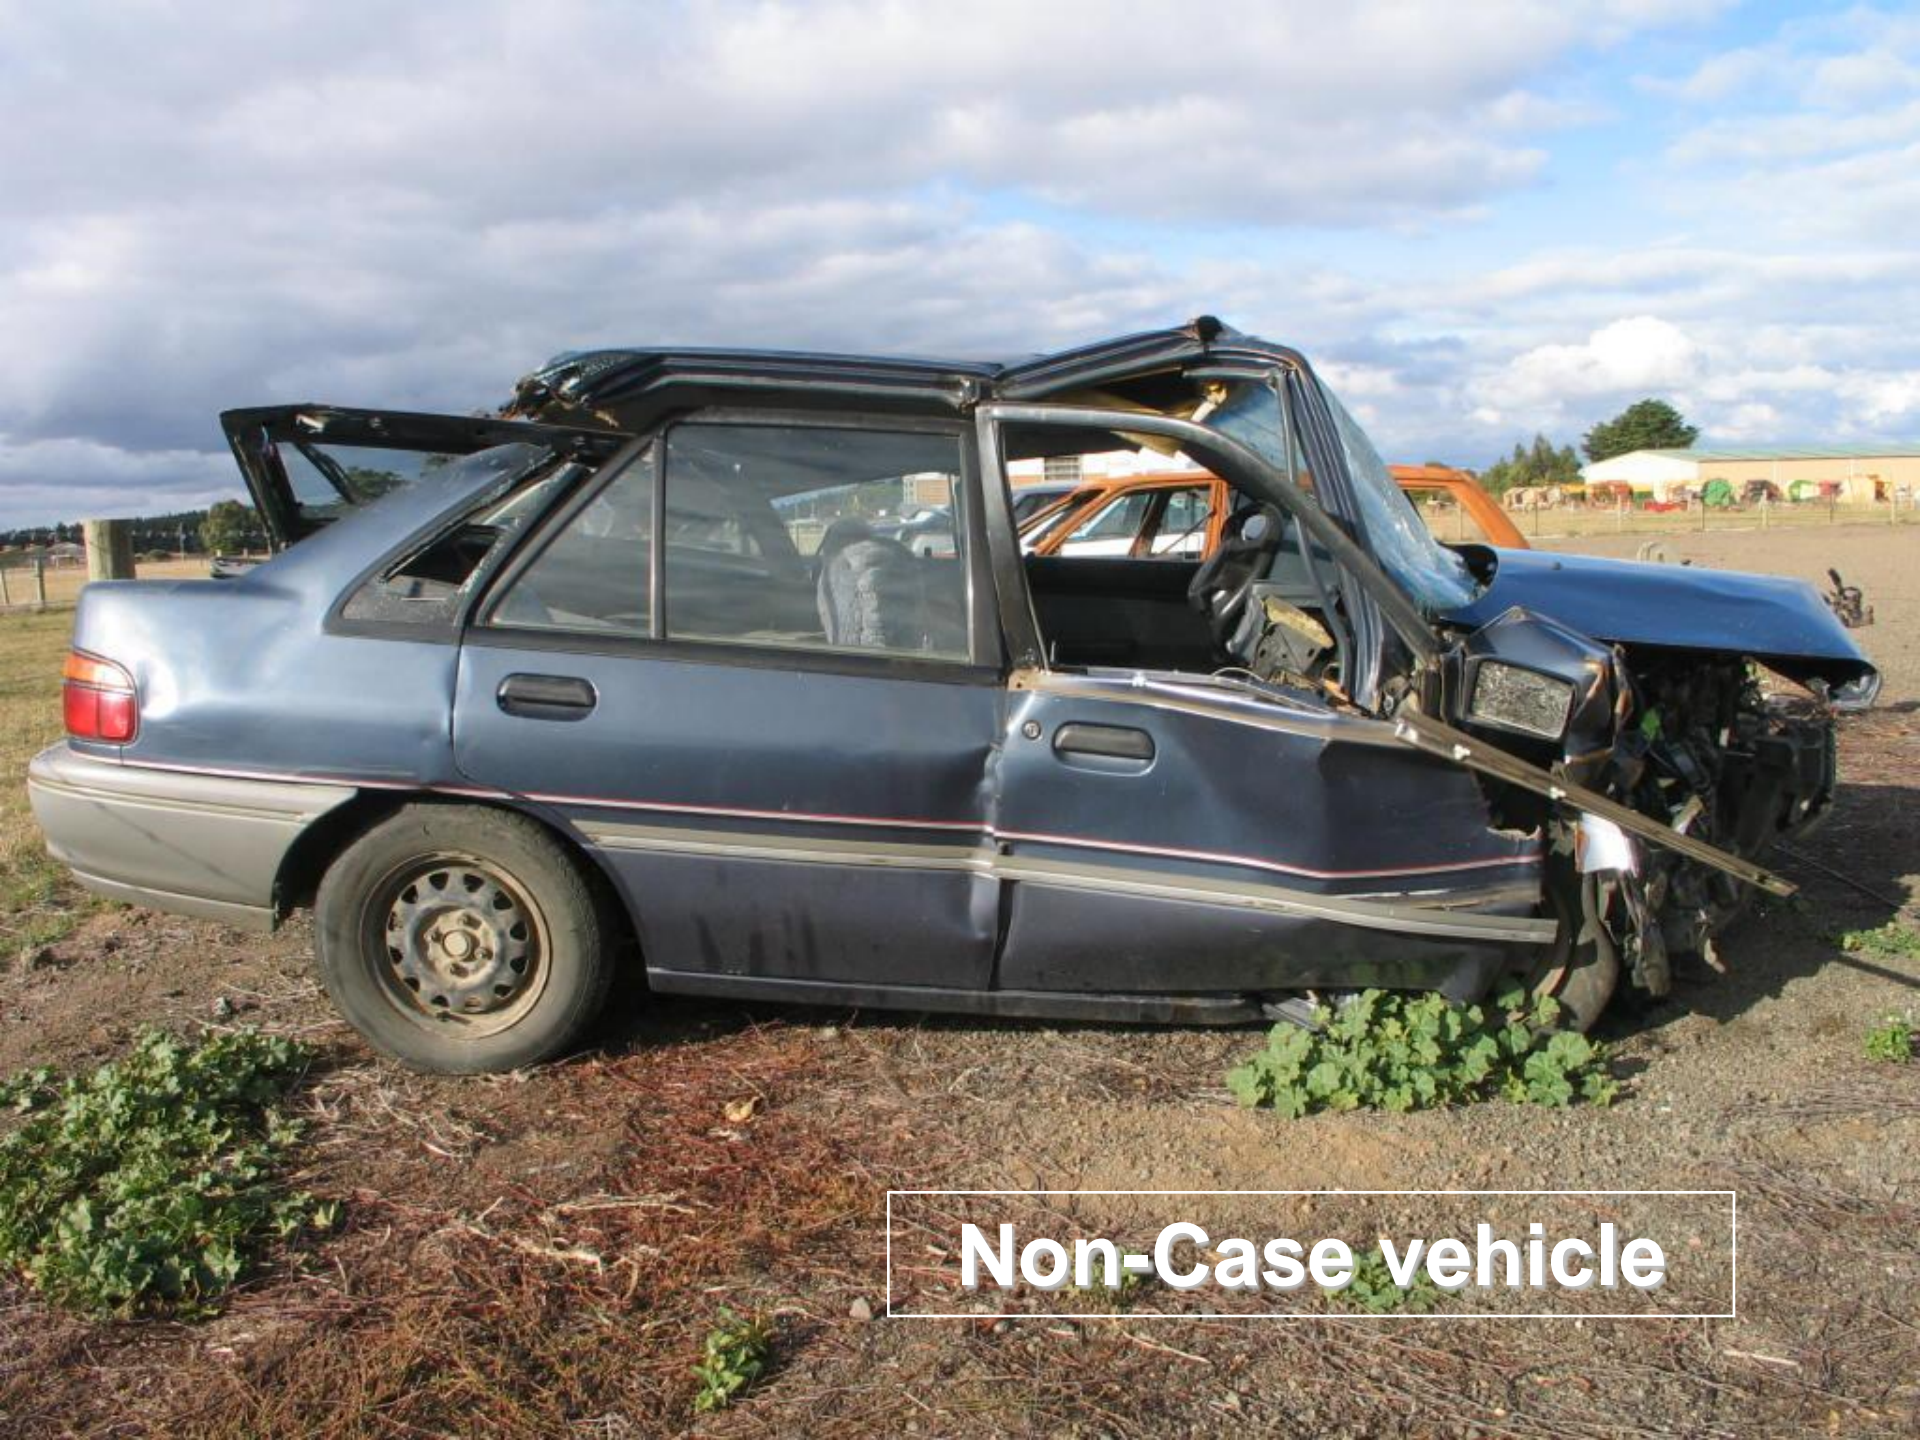
Case Vehicle

- 2002 Large Australian passenger sedan (CASE)
 - 4.0 litre, automatic, 1700kgm
- 1990 Small passenger hatchback sedan (NON-CASE)
 - 1.6 litre, manual, 900kgm
- 1 o'clock impact (Case vehicle)
 - Offset to driver's side
- Impact Severity (Delta-V)
 - 35km/h (Case), 75km/h (Non-Case)
- Maximum crush depth:
 - 920mm (Case), 1160mm (Non-Case)

- Both vehicles were roadworthy and in reasonable condition
- Used car safety ratings
 - *Case vehicle* – “significantly better than average”
 - *Non-case vehicle* – “average”
- Case vehicle restraints
 - *Usage markings on driver and adult passenger’s seat belt assemblies*
 - *Steering wheel and fascia airbags deployed*
 - *Driver’s pretensioner activated*
 - *Plastic housing on passenger’s seat belt tongue cracked*
 - *No pretensioners, load limiters, to rear seat belt assemblies*

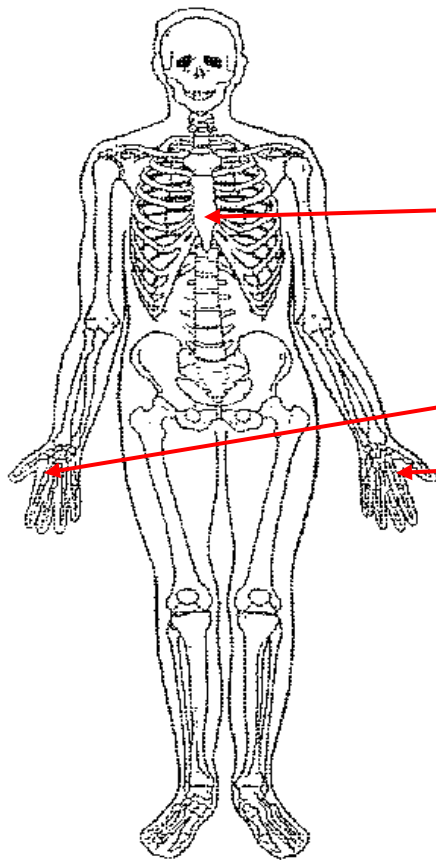
Driver Injuries

1. Bruising to chest (around sternum) (AIS1)

2. Lacerations to right hand (AIS 1)

3. Bruising to left hand (AIS1)

ISS = 2

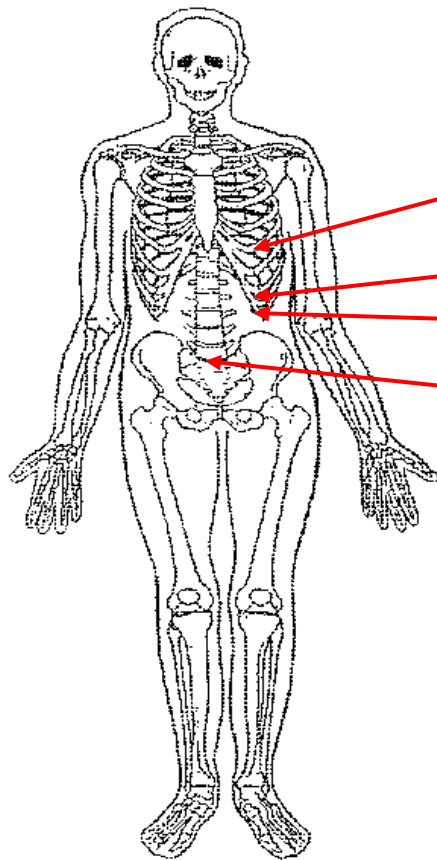
Female Passenger Injuries

1. Fractures to four ribs (bilateral, R6-9) (AIS 4)

2. Bruising to spleen (AIS 2)

3. Laceration to left kidney (AIS 3)

4. Bruising to abdomen (AIS 1)

ISS = 25

Most injuries attributed to poor alignment of the seat belt

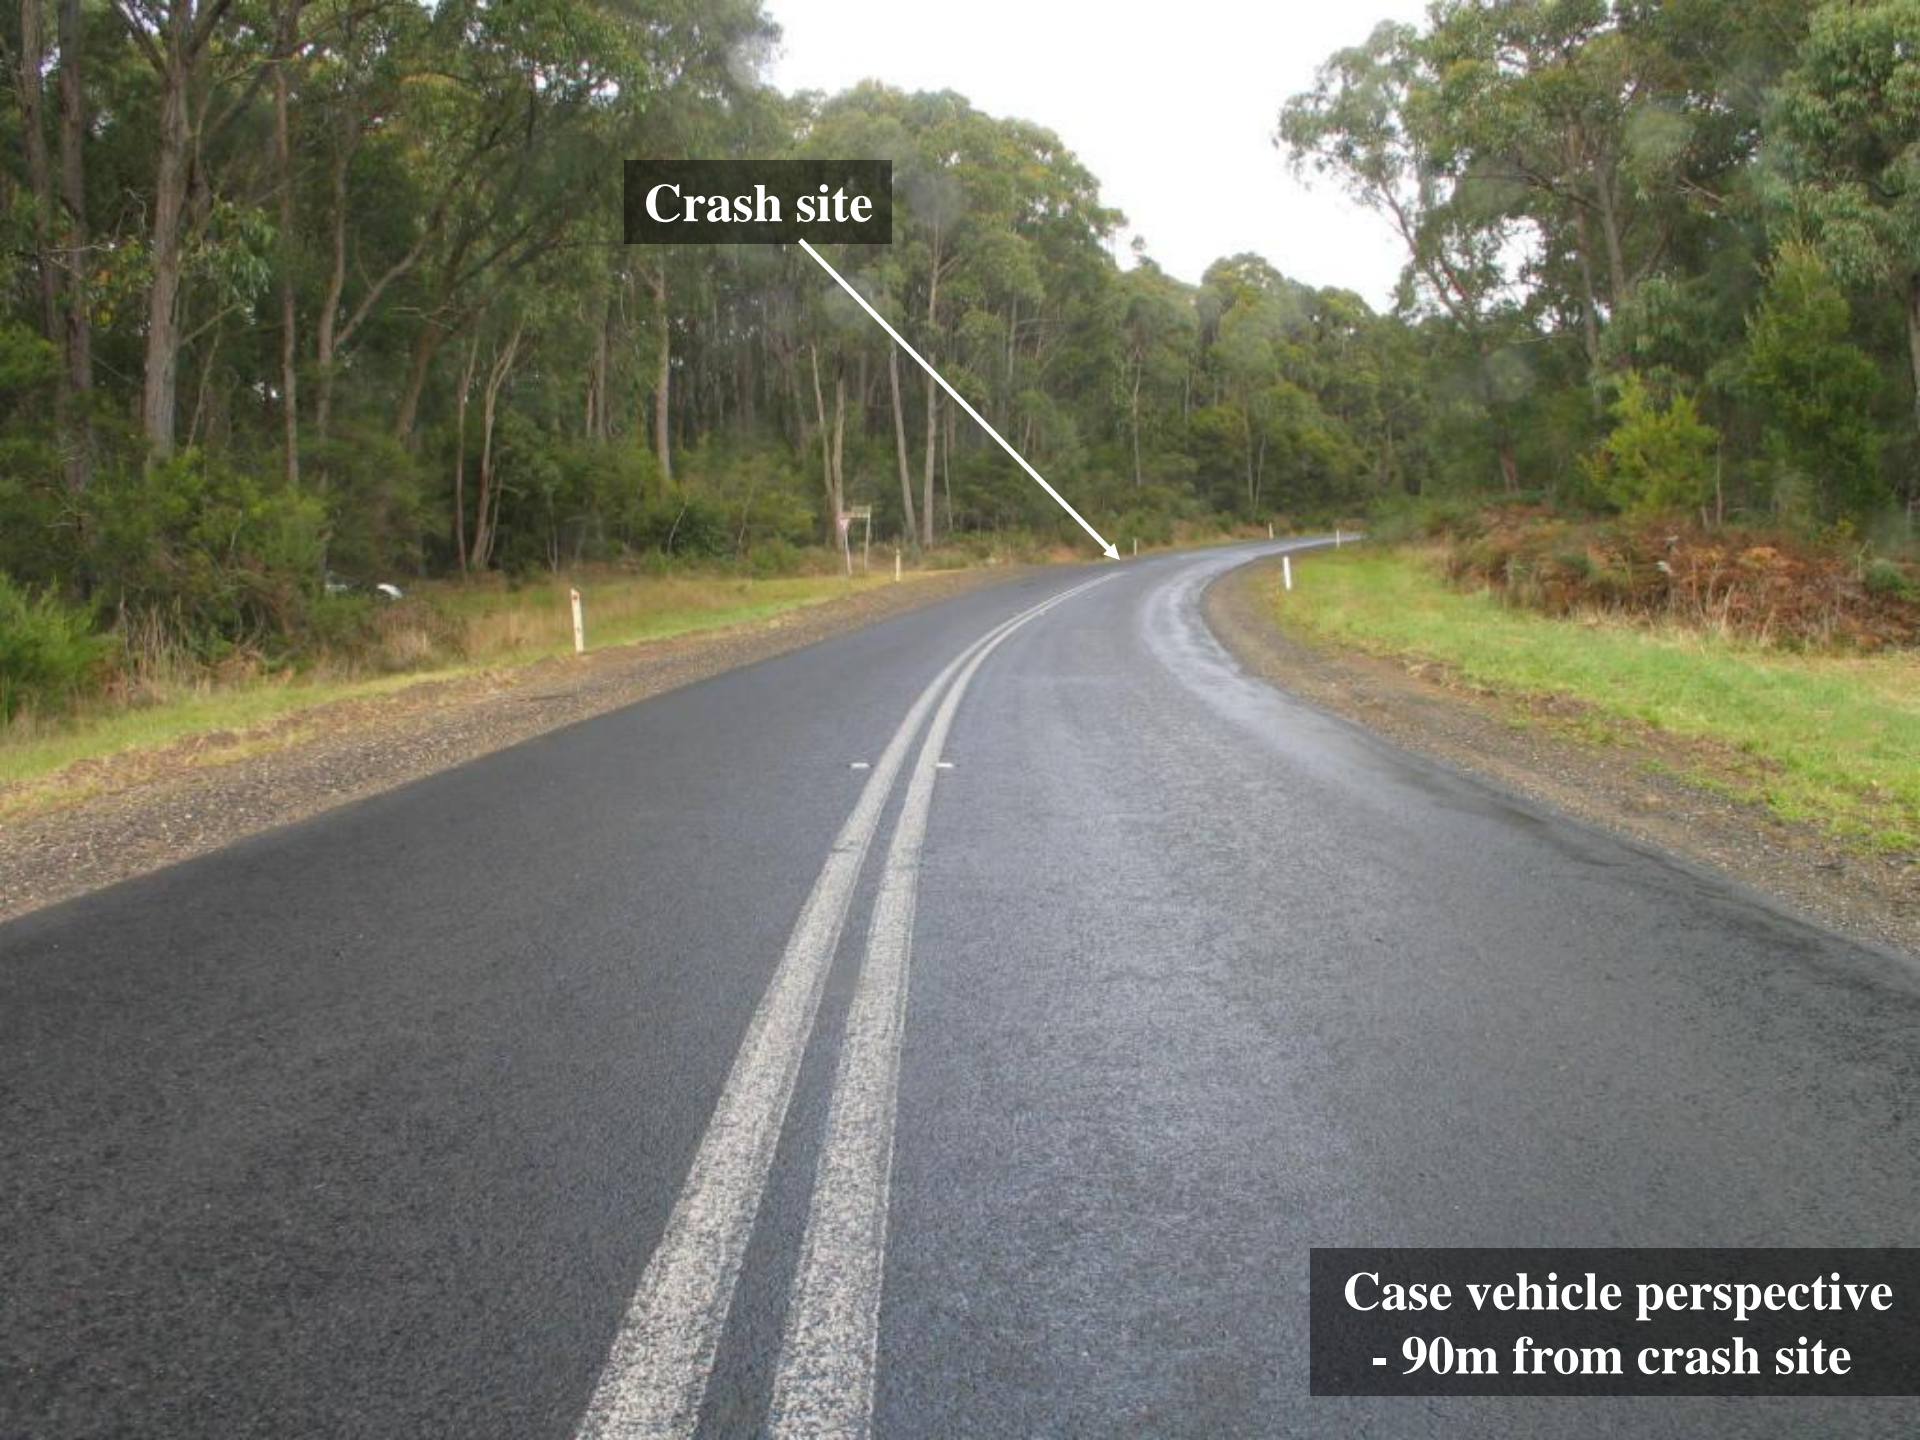
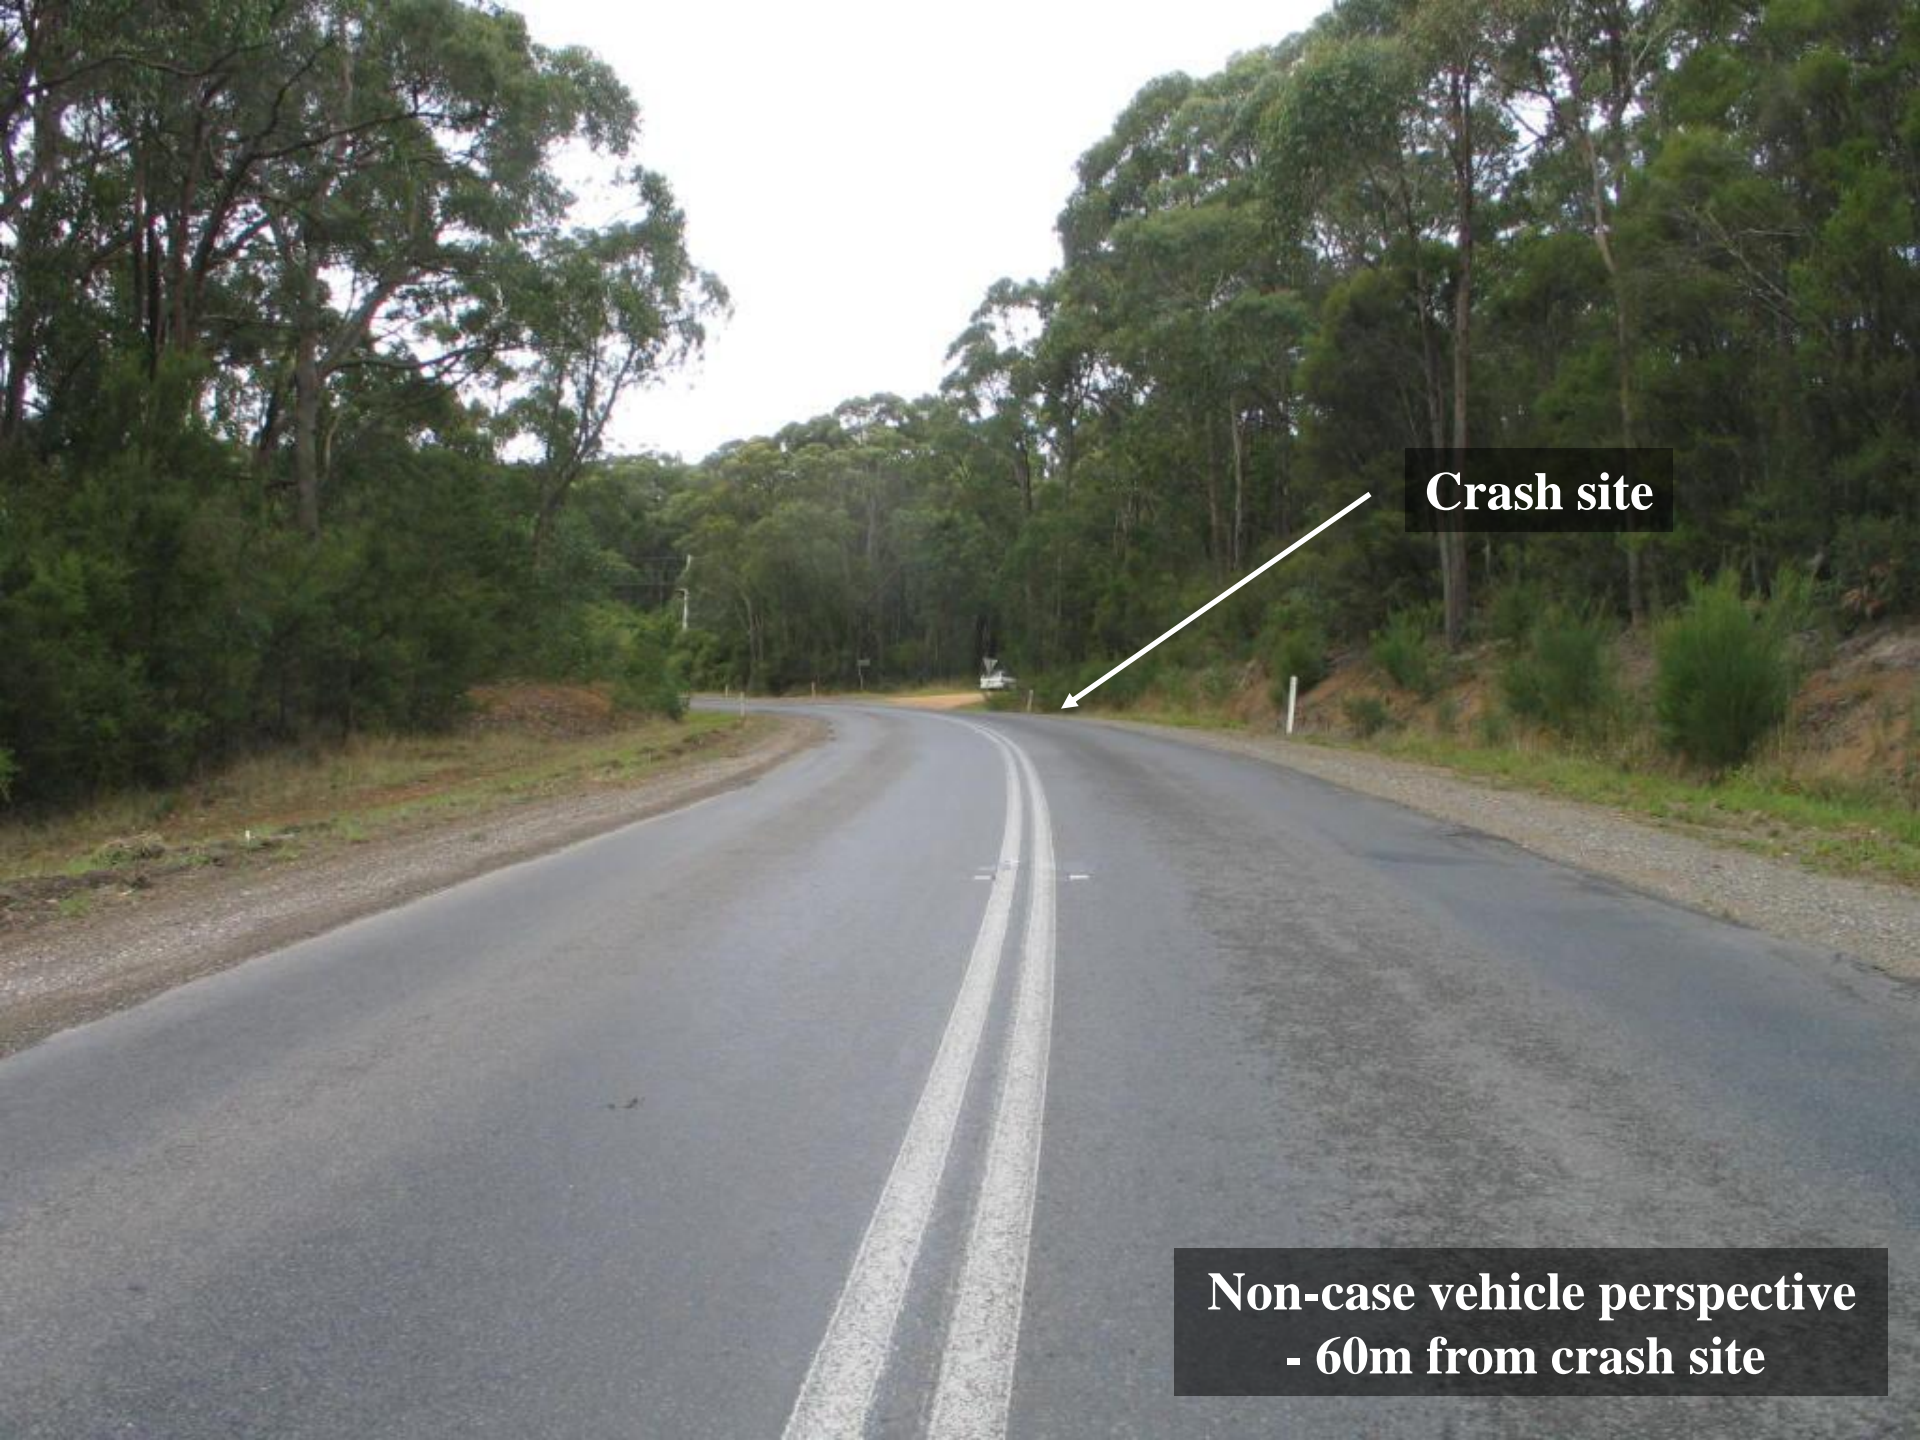
**Case vehicle perspective
- 90m from crash site**

- Gentle uphill slope
- Right-hand curve, radius 250m
- Undivided 2-lane hwy, each lane only 3m wide
- Nearside shoulder 2m wide, unsealed, poor drop-off
- Offside shoulder 2.7m wide, unsealed, poor drop-off
- 100 km/h speed zone
- 900 vehicles per day (average)
 - *Mainly commercial (timber) route*
