# Feasibility of using Deflectograph data to review drainage network in the UK

- Morteza Zohrabi
- Mott MacDonald Ltd, UK
- Pavement Manager
- [morteza.zohrabi@mottmac.com](mailto:morteza.zohrabi@mottmac.com)

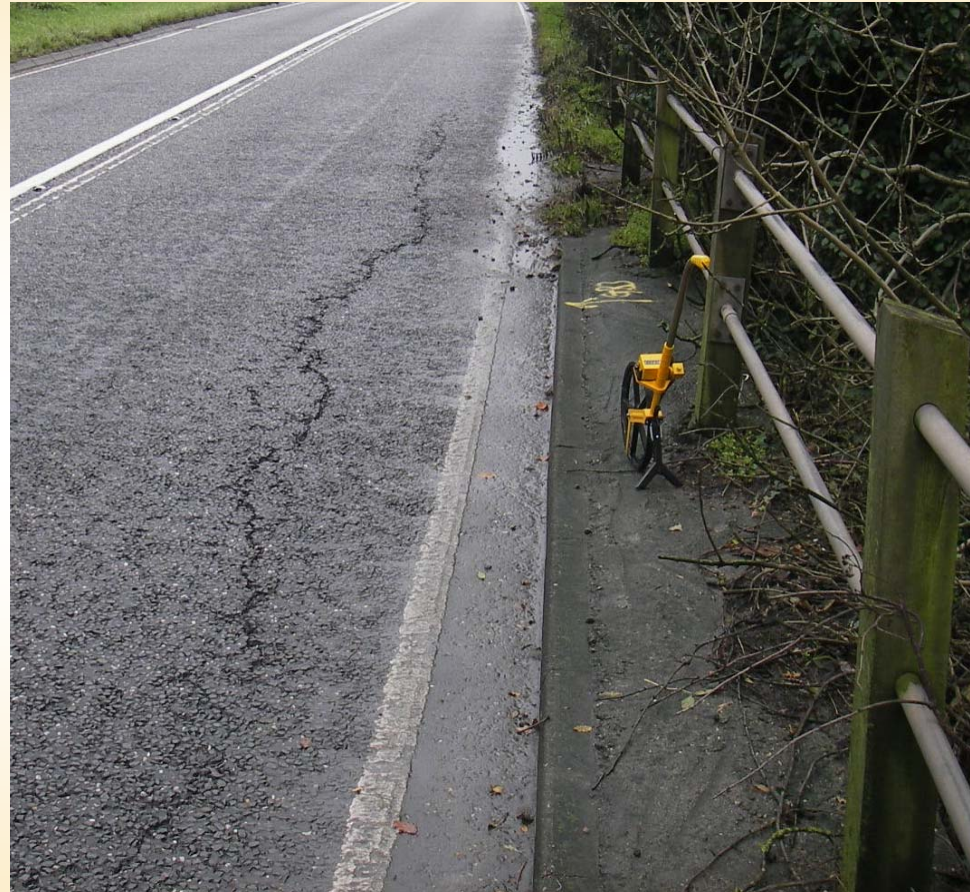
# Case study 1: A30 Honiton to Haynes Farm

- A 2-way trunk road.
- Some lengths containing no positive drainage that occasionally flood.
- Drainage mostly piped system (carrier drains).
- An over-flown stream floods the road in heavy rain.
- Constant flooding of pavement foundation at this location.

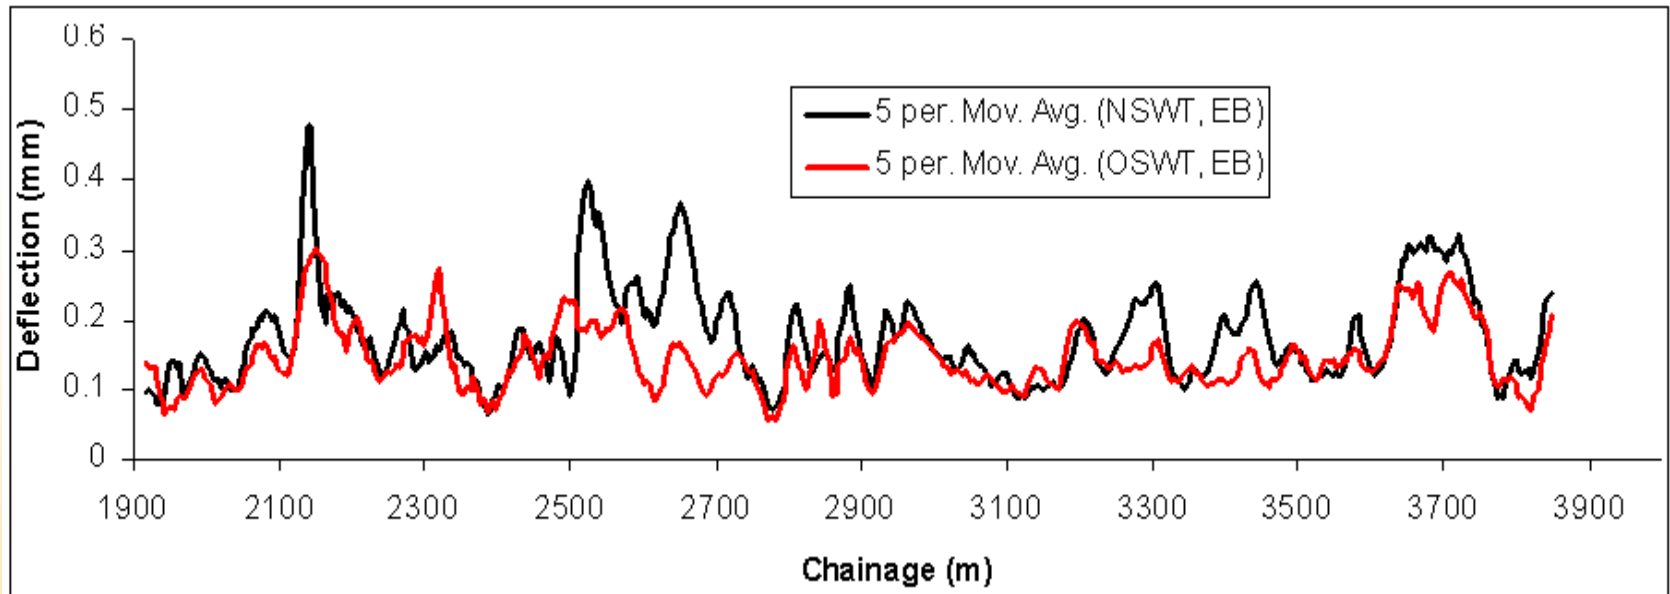
## Case study 1 – EB direction

- **No drains from 2300 to 2700m and 3200 to 3500m:**
  - High deflection on the NSWT in both locations
- **Centreline joint cracking from 3300 to 3800m:**
  - Both deflections high but seepage water affected NSWT more than OSWT

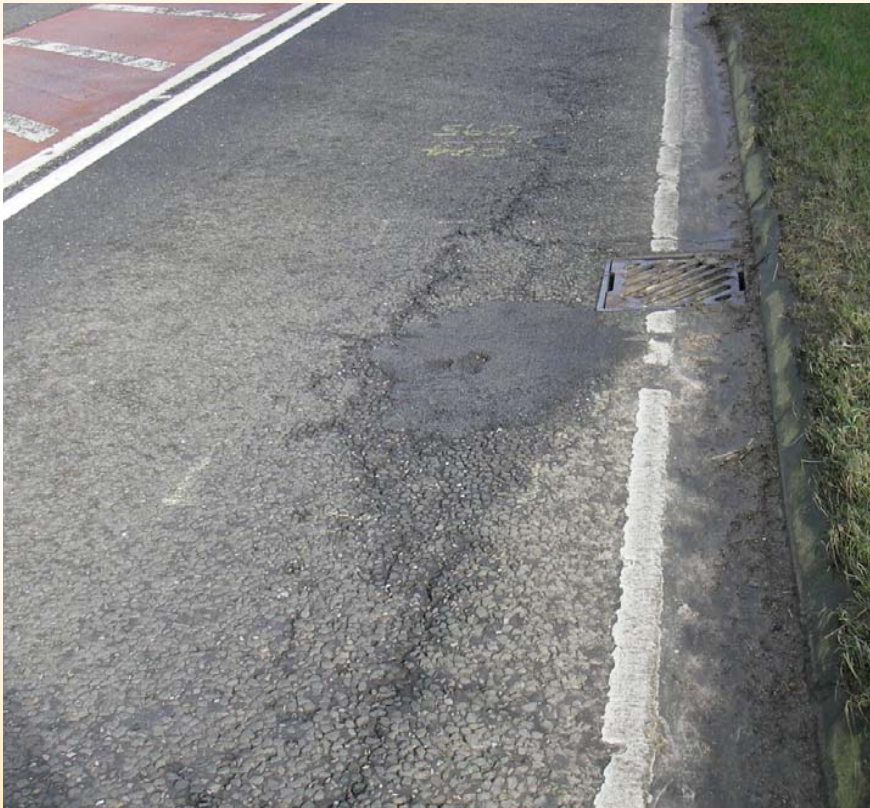
## Case Study 2: A30 Rawridge Hill to Devonshire House

- Extensive longitudinal (alligator) cracking along the NSW T
- Poor drainage with water ponding on the road during prolonged periods of rain

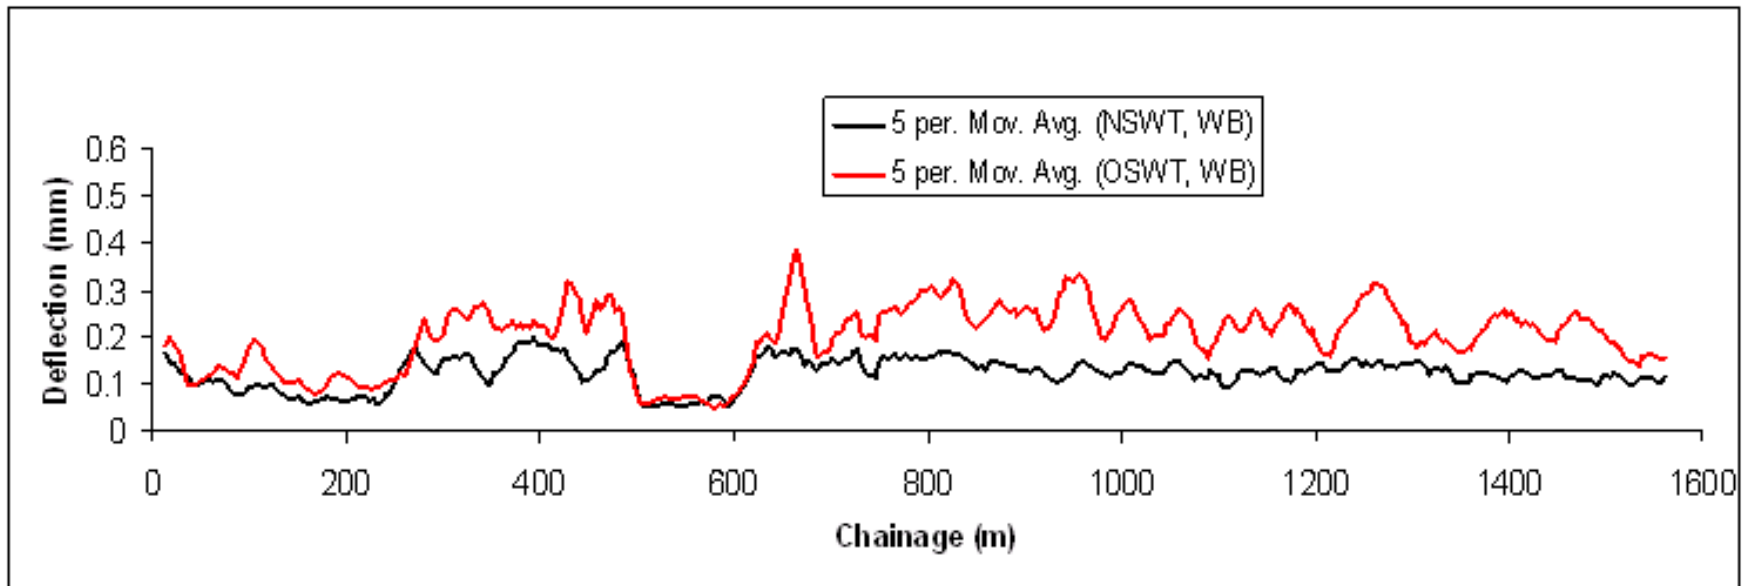
## Case Study 2 – WB carriageway

- Higher deflection on the OSWT than the NSWT
- Severe centreline joint cracking for chainage 1000 to 1200m
- Possible weakening of the foundation of the OSWT due to seepage water

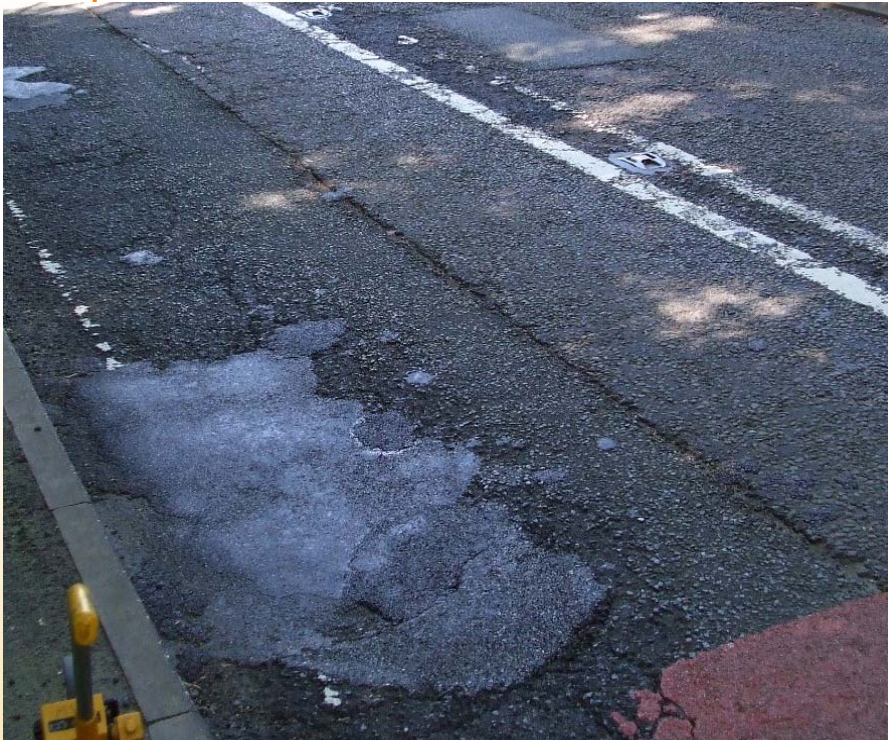
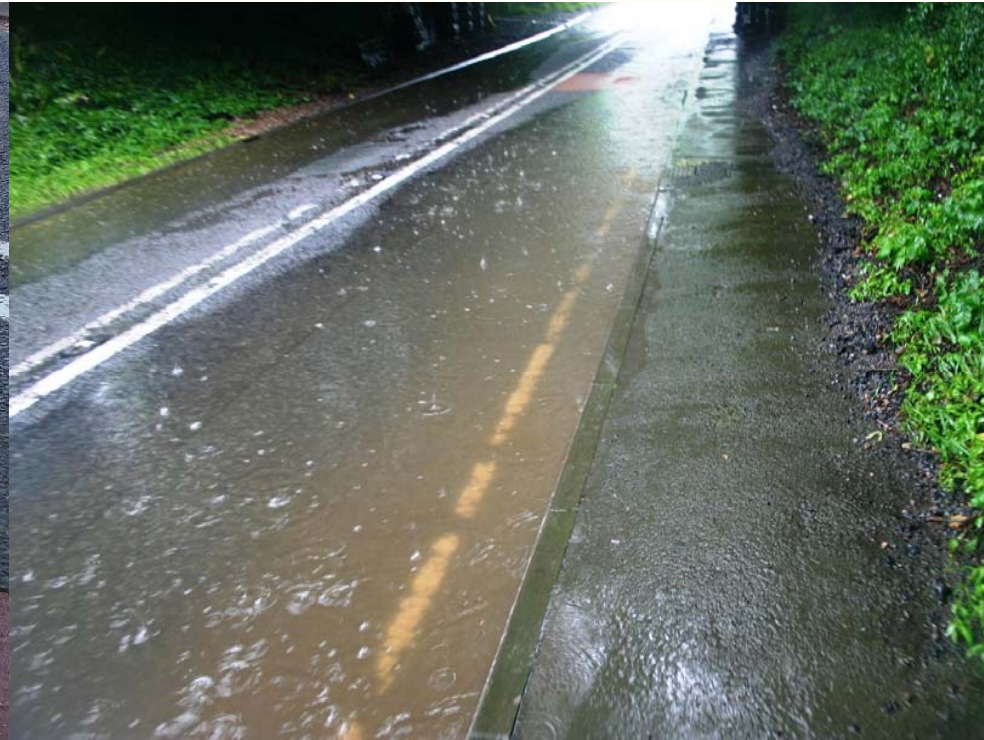
## Case Study 3 : A40 Huntley to Lea

- **Main drivers on this 6km long scheme:**
  - Extensive surface disintegration
  - Localised NSW cracking and collapsed gullies
  - NSW flooding in heavy rain for most length, requiring emergency call outs
