The Enhanced Crash Investigation Study (ECIS)

Monash University Accident Research Centre, Australia

**A head-on crash on a 2-lane
undivided narrow rural hwy**

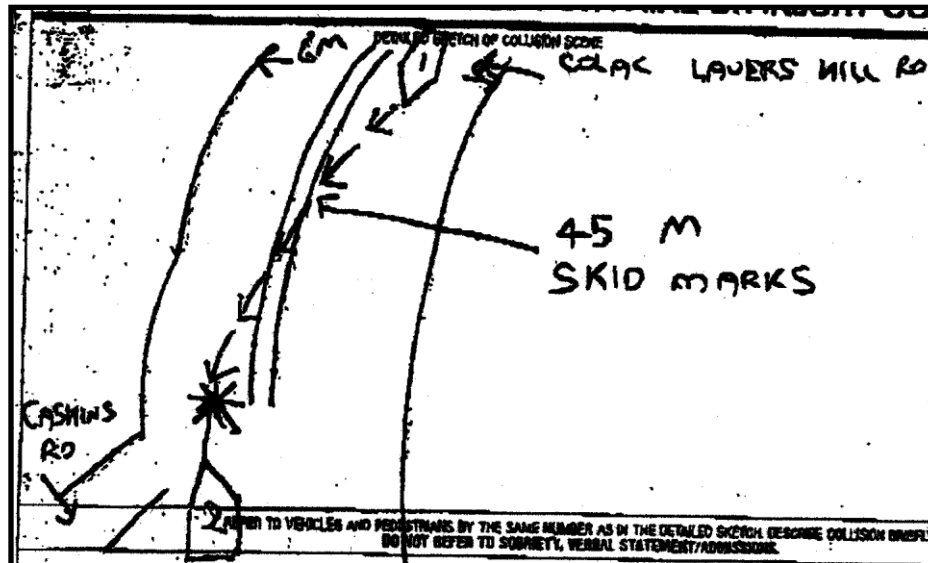
Police Report

“ Vehicle 1 [non-case] travelling north on Lavers Hill Road and intending to turn right into Cashins Road. Crossed double lines and struck unit 2 [case] travelling south on Colac – Lavers Hill Road”.

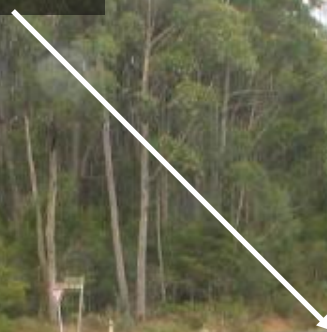
Crash site

- Gentle uphill slope
- Right-hand curve, radius 250m
- Undivided 2-lane hwy, each lane only 3m wide
- Nearside shoulder 2m wide, unsealed, poor drop-off
- Offside shoulder 2.7m wide, unsealed, poor drop-off
- 100 km/h speed zone
- 900 vehicles per day (average)
 - *Mainly commercial (timber) route*

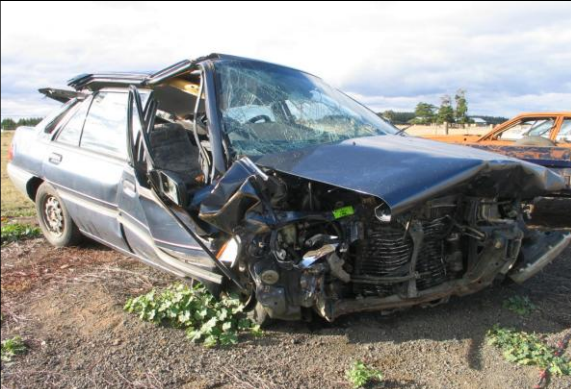
Crash Causation Summary

Road/Roadside Setting	Vehicle	Case Vehicle Driver
Speed zoning (crash/injury severity)	Case vehicle OK (rear seatbelt align?)	None identified
Poor road surface/edging	Poor crashworthiness (non-case vehicle)	Non-Case Vehicle Driver
Poor road delineation

Failure to observe traffic control
Restricted sight distance due to alignment No curve chevrons		Driving without due care and attention???
